Concepts and Science for Coastal Erosion Management

Inch Beach – Pilot Site

27th April 2009

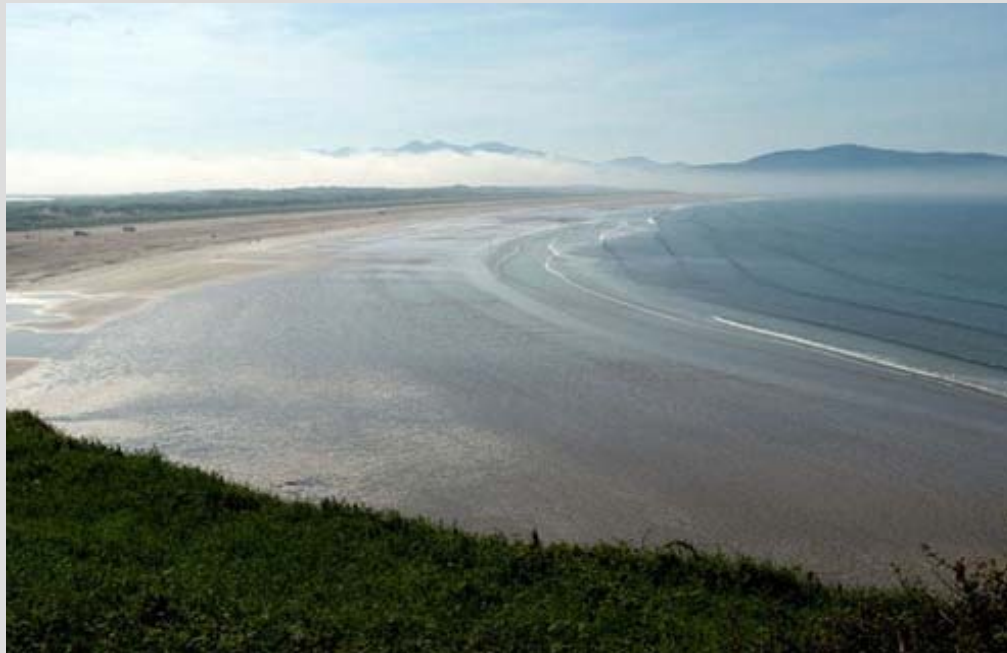
Inch Beach – Background

- length: 5.5 km
- large barrier-dune system
- dissipative shore-face (slope 1:100 nearshore)
- spring tidal range 3.2 m
- embayment (30 km²) constrained by resistant headlands
- fixed sediment volume
- ebb tidal delta: sink and source of sediment

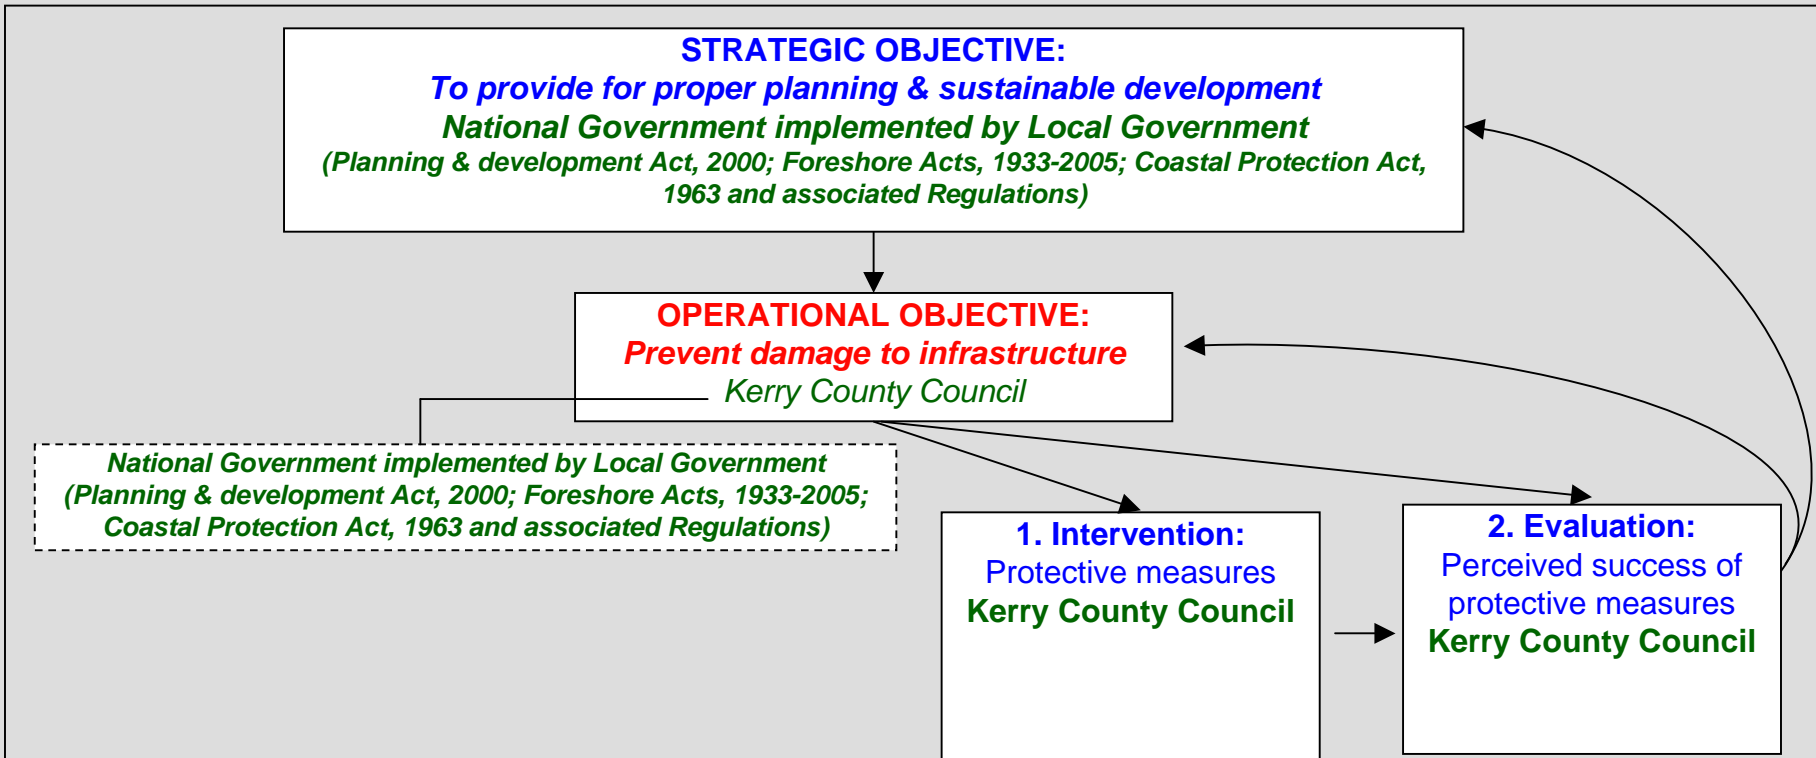
Frame of Reference - Real Institutional Framework

Need for integrated dedicated Act or Policy, current legislation is contradictory & therefore subject to interpretation (abuse?).
